CACHING UNDERWATER 197A
STORAGE CONTAINER

II RESULTS OF INSPECTION OF SEA-
WATER-IMMERSED CONTAINERS
AND SPECIMENS - CONDUCTED
MAY 27-30, 1958

INSPECTION OF ORIGINAL AND MODIFIED ALUMINUM- ALLOY AND STAINLESS STEEL CIRCULAR-CROSS- SECTIONED CONTAINERS

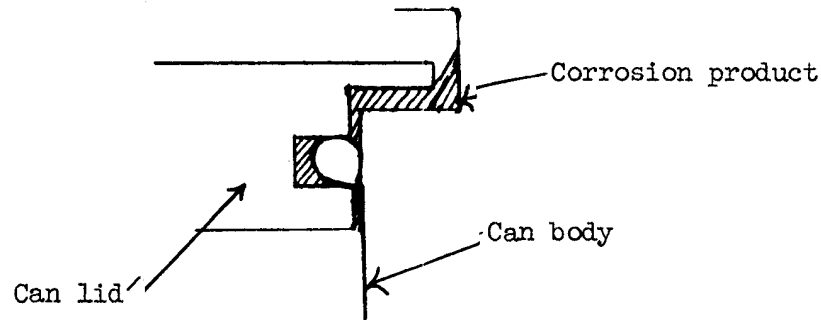
No moisture or water inside can. Space between O-ring and O-ring groove in can lid filled with dry, hard, gray corrosion product which had smooth, glassy surface where in contact with O-ring. Similar product occupied space between lid and can head exterior to O-ring, and extended beneath O-ring to interior of can head. This corrosion product made removal of lid difficult. Through build-up of corrosion product in O-ring

groove, O-ring deformed in cross section, being ovate with lip projecting toward interior, thus:

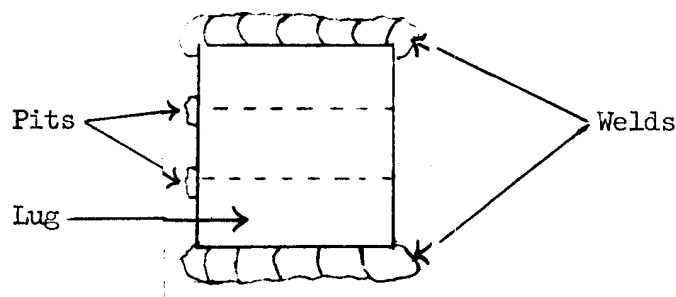
Approximately 1/4 of can body, including two handles, was cleaned and examined for corrosion attack. Two small pits, 1/16 to 1/8" in diameter, estimated to be 1/64 to 1/32" deep, found. Shallow etching and pitting also found associated with handle lugs, thus:

This attack much less severe than that noted on Container No. 11(M).

Container stored at the NFRS, pending receipt of a new lid. If a lid can be secured, the specimen will be replaced on exposure.
